4. TITLE (and Subtitle) Phase I Dam Inspection Report National Dam Safety Program Maddox Lake Dam (MO 30024) Wayne County, Missouri		5. TYPE OF REPORT & PERIOD COVERED  Final Report

MADDOX LAKE DAM  
WAYNE COUNTY, MISSOURI  
MISSOURI INVENTORY NO. 30024

PHASE I REPORT  
NATIONAL DAM SAFETY PROGRAM

Name of Dam	Maddox Lake Dam
State Located	Missouri
County Located	Wayne County
Stream	Unnamed tributary to Rings Creek
Date of Inspection	10 & 11 July 1978

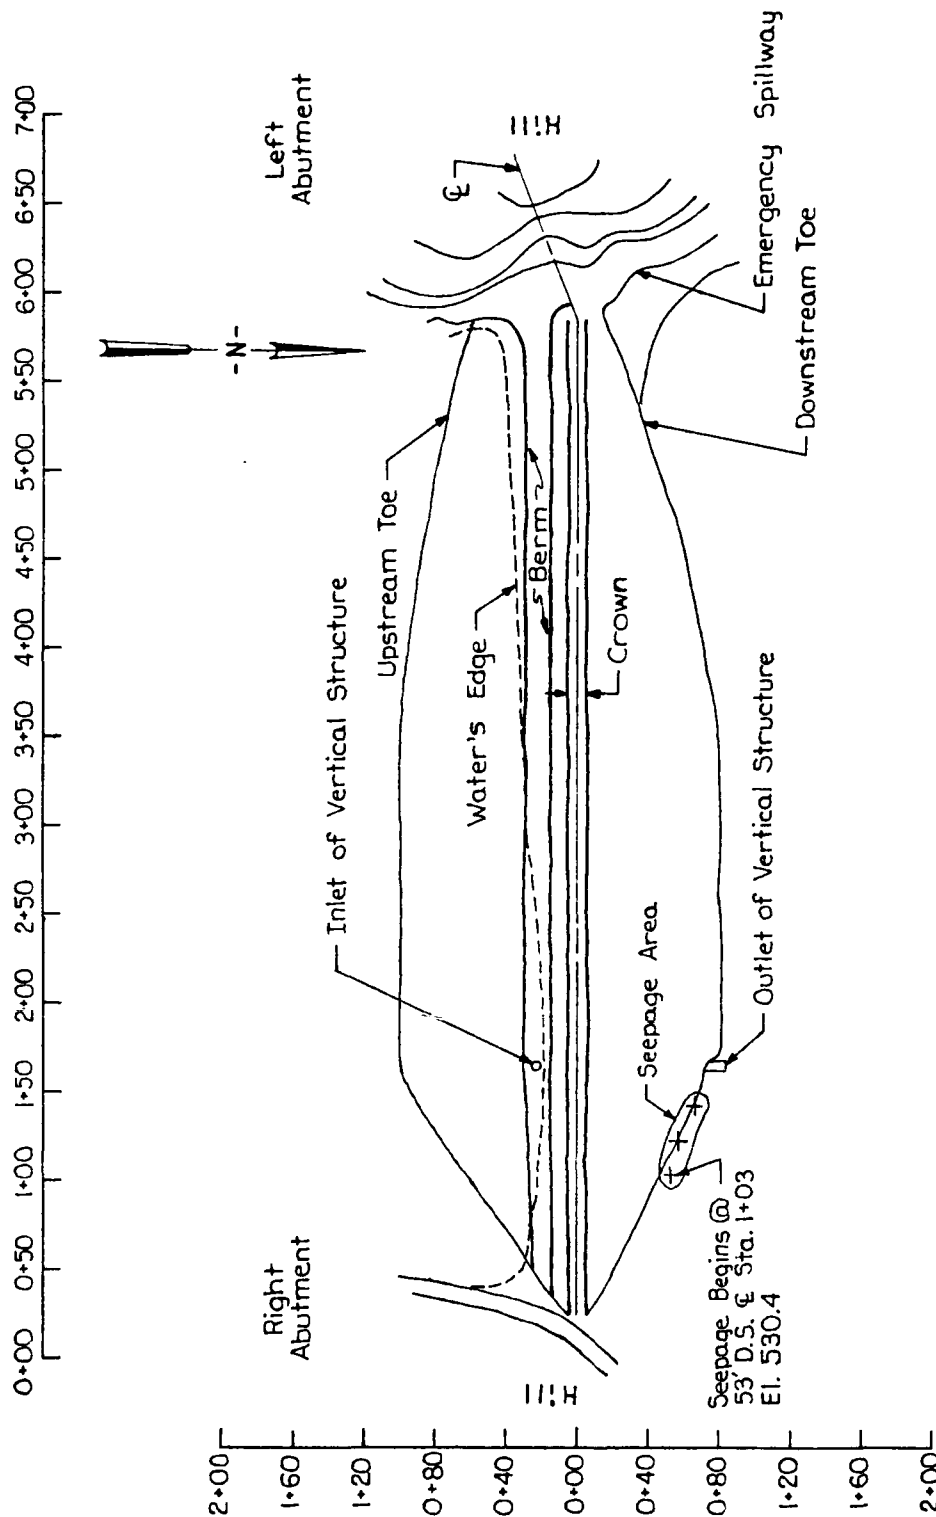
DAM PLAN VIEW

Seepage was observed flowing at an estimated 5 gpm from the right abutment in the area shown on Plate 3. The seep water was reddish in color, indicating flow through a high iron content soil (see Photo 5) and had a temperature of 63°F. The owner of the dam stated that before the dam was constructed, a spring flowed from this area with reddish water and another spring flowed from an area approximately 500 feet downstream of the right abutment. He also stated that there are iron deposits in the hill which the right abutment adjoins. The downstream spring was located flowing from the hill with clear water having a temperature of 70°F. A temperature profile of the lake was performed with the following results:
